ANNUAL REPORT FOR 2005

Indian Creek Mitigation Site

Lincoln County

Project No. 8.1811002

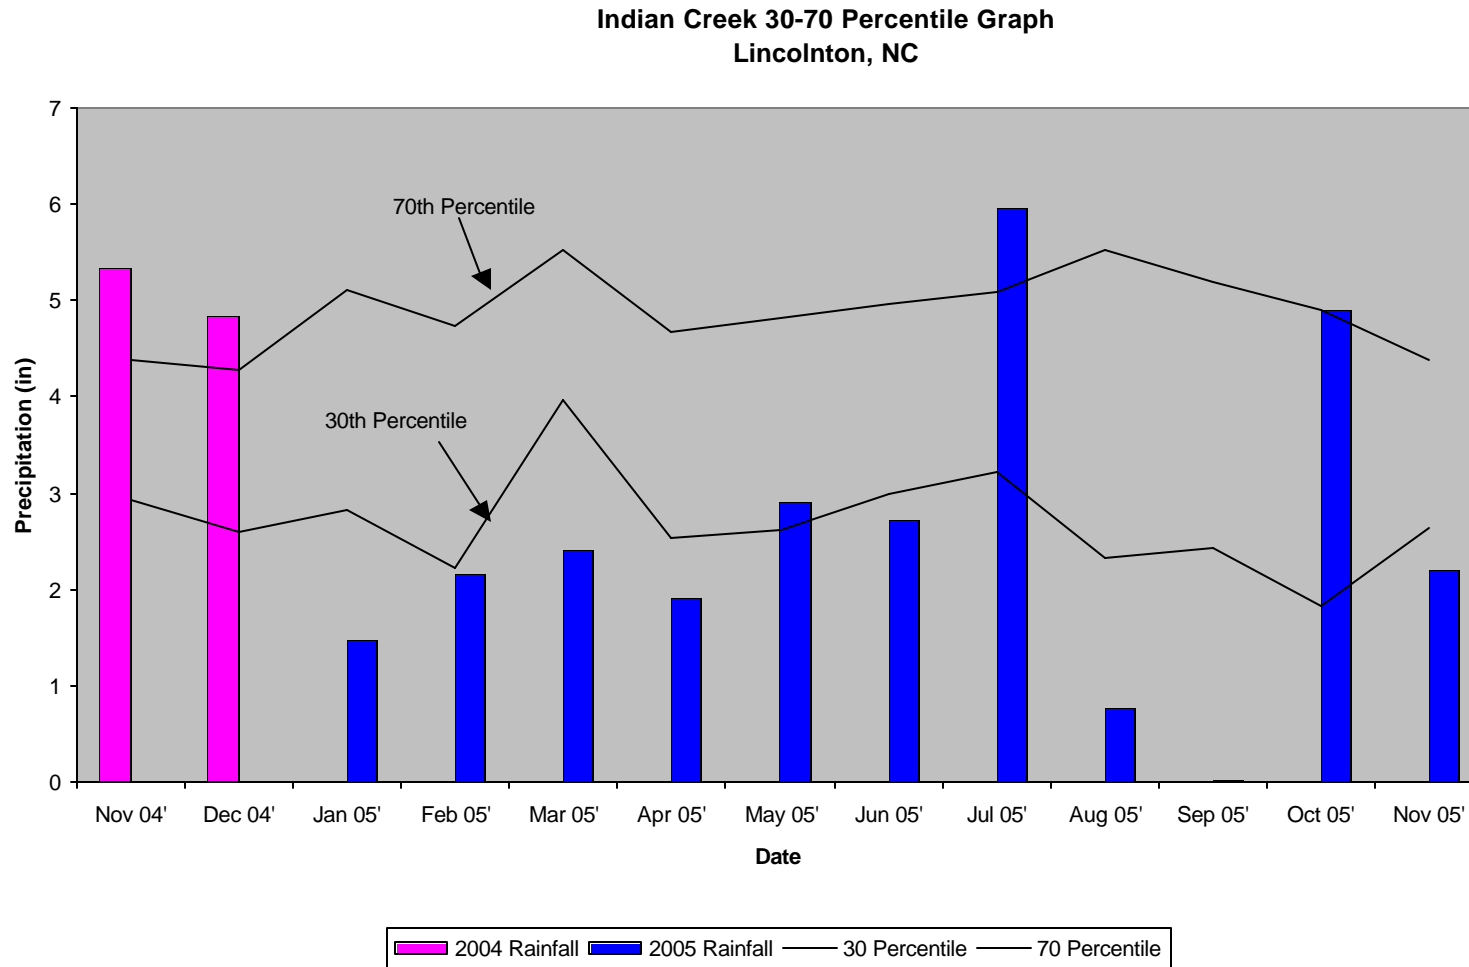
Figure 4: 30-70 Percentile Graph

Figure 4 is a comparison of monthly rainfall for the period of November 2004 through November 2005 to historical precipitation (collected between 1974 and 2005) for Lincolnton, North Carolina. This comparison gives an indication of how 2005 relates to historical data in terms of climate conditions. The NC State Climate Office provided all local rainfall information.

For the 2005-year, November ('04), December ('04), July, and October experienced above average rainfall. The months of January, February, March, April, June, August, September, and November recorded below average rainfall for the site, while May recorded average rainfall. Overall, 2005 experienced a below average rainfall year.
